2020 年度 景林邨 消防年檢 維修工程 完工報告

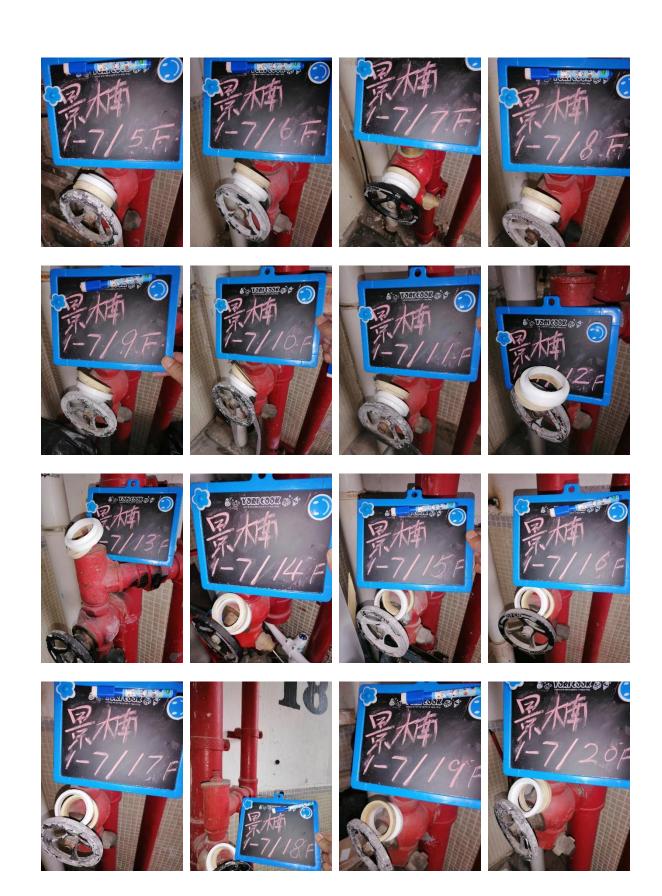
位置:01-07 翼(34 個)

8)換新龍頭白膠圈

原因:老化

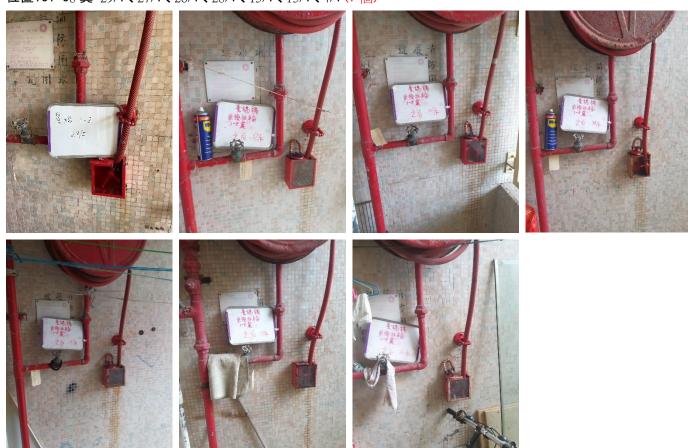
位置:01-08 翼-29/F、27/F、26/F、28/F、15/F、13/F、4/F(7個)

3)換新喉轆拉輪

原因:損壞

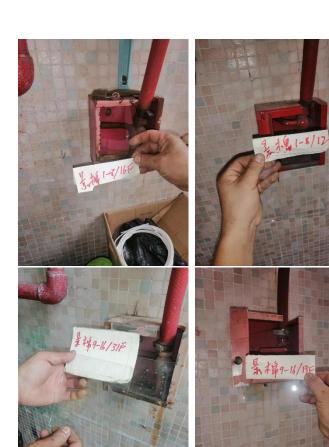
位置:09-16 翼-31/F、13/F(2 塊)

6)換新射咀箱之玻璃

原因:損壞

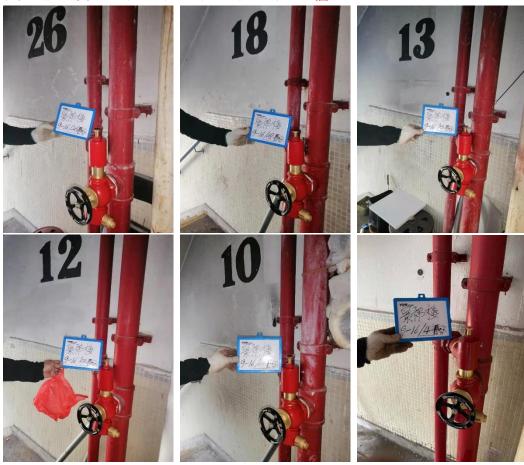
位置:09-16 翼-26/F、18/F、13/F、12/F、10/F、4/F 6 個)

12)換新 80mm 吸入式(2 吋泡水)龍頭連龍頭系統入水工作

原因:損壞

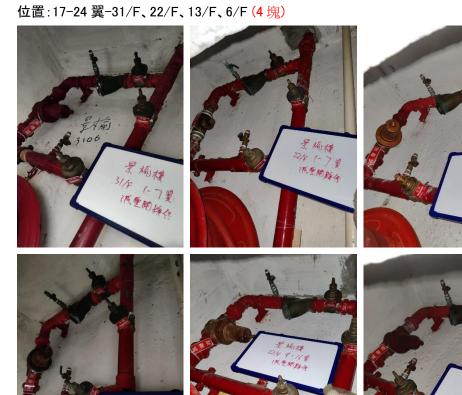
> 景榆樓 31年 9-16 盟

10)新加裝"減壓閥"指示膠牌仔

原因:欠缺

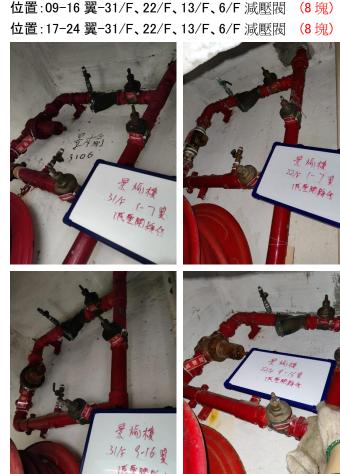
位置:01-07 翼-31/F、22/F、13/F、6/F 減壓閥 (8塊) 位置:09-16 翼-31/F、22/F、13/F、6/F 減壓閥 (8塊) (8塊)

11)新加裝''常開'' 膠牌仔

原因:欠缺

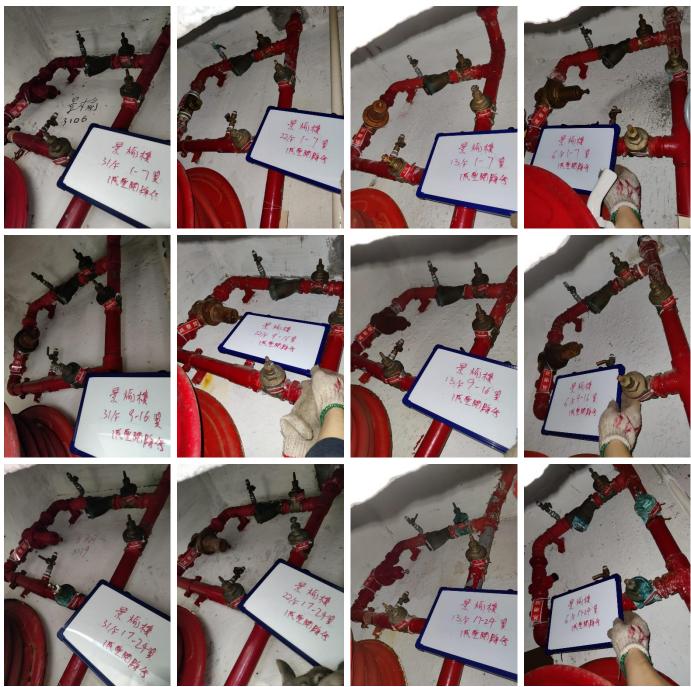
位置:01-07 翼-31/F、22/F、13/F、6/F 減壓閥 (4塊) 位置:09-16 翼-31/F、22/F、13/F、6/F 減壓閥 (4塊) 位置:17-24 翼-31/F、22/F、13/F、6/F 減壓閥 (4塊)

12) 新加裝"常關" 膠牌仔

原因:欠缺

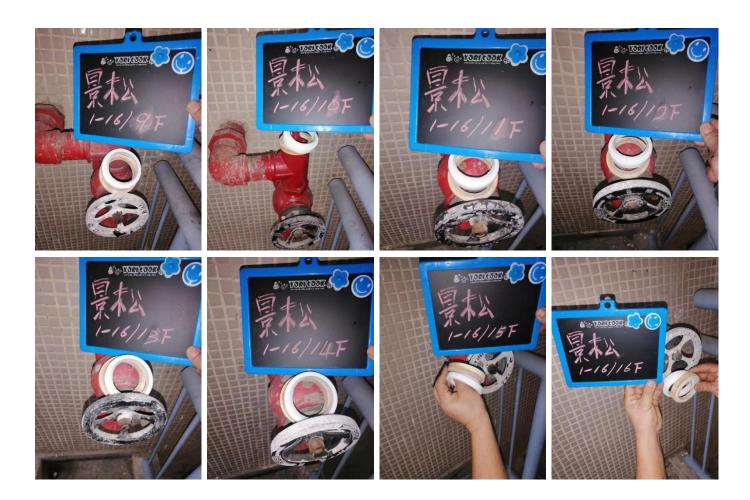
位置:01-16 翼-16/F-1/F (16 個)

6)換新龍頭白膠圈

原因:老化
